FINAL
REPORT OF
PRODUCT IMPROVEMENT TEST OF U-8F
(ECP-BEA-L23-138)
USATECOM PROJECT NO. 4-4-1004-01

22 DEC 1964

U S ARMY
AVIATION TEST BOARD
FORT RUCKER, ALABAMA

PRODUCT IMPROVEMENT TEST OF THE U-8F

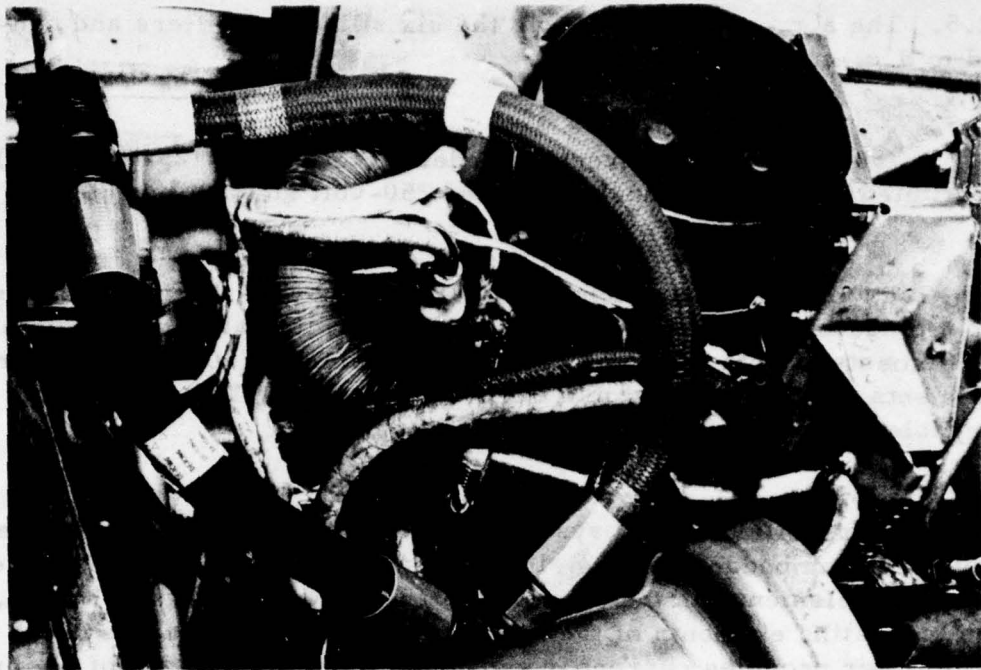
1.5.1. The generating system consists of the two 300-ampere, brushless generators (figure 1) with integral silicon-controlled rectifier voltage regulators, two control panels, and associated wiring harnesses. The control panels are designed to provide system current-regulation, reverse-current, and over-voltage protection. The generating system weighs 137.6 pounds and has a rating of 100 amperes at 1000 engine r.p.m. (2600 generator r.p.m.) and 300 amperes at 1500 engine r.p.m. (3900 generator r.p.m.) and above.

Figure 1. Brushless generator installed on U-8F Airplane.

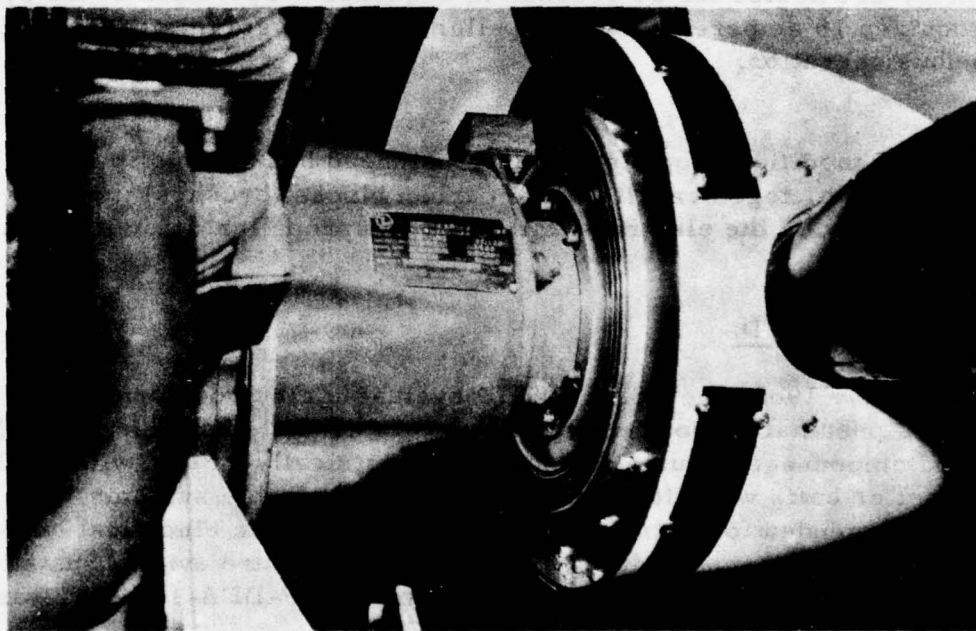
Figure 2. Modified propeller spinner bulkhead showing slip rings.

1.5.6. The modified propeller spinner bulkhead has three slip rings (figure 2) which, together with three carbon blocks (brushes) mounted on the engine, provide the electrical circuit to the propeller deicing boots.
